Monitoring of Pine, Calvin, Point, and Fischer Creeks in Southern Manitowoc County Summer 2012

Student Interns: Heather Havel, Elizabeth Binversie,
Hailey Rogala

Friends of Hika Bay
Calvin, Pine, Point, Fischer, Centerville Creeks

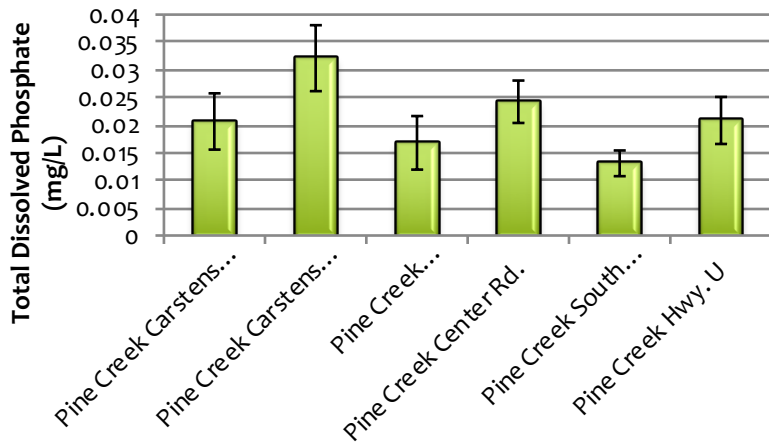
Pine Creek Graphs

- * Phosphate levels do not follow the general trends seen in other streams of increasing downstream
- * Phosphate and turbidity levels spike between Sonnenberg Lane and Center Road
- * Ammonia nitrogen (NH_4) level at Center Road greatly increases.
- * Between Sonnenberg Lane and Center Road there is a spike in E. coli

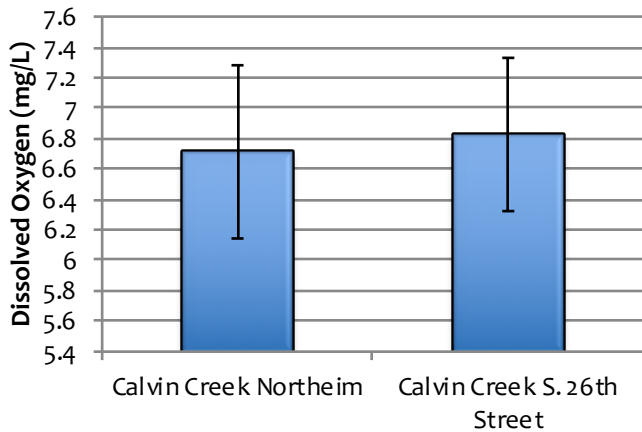
Calvin Creek – Physical Parameters

- * Turbidity and phosphate levels were above the normal range
- * E. coli average was found to be well over the “closed” value
- * Phosphates , E. coli, and turbidity increased downstream
- * Ammonia nitrogen decreased downstream

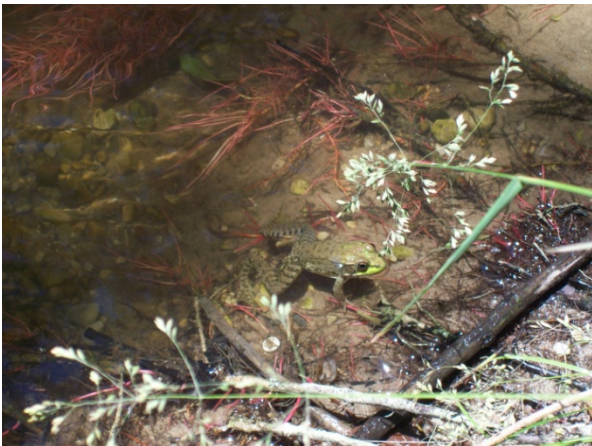
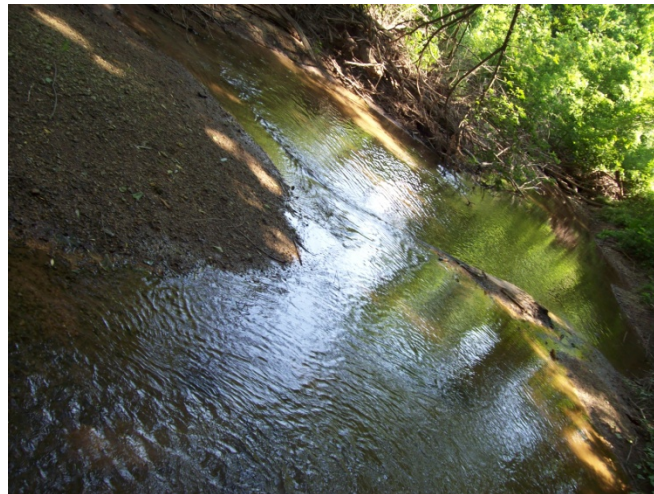
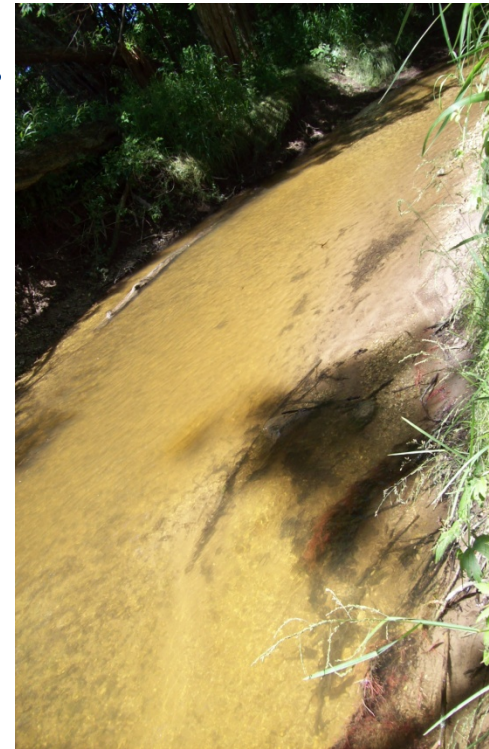
- * Turbidity was consistently well above the normal range.
- * Phosphates were slightly above normal ranges.
- * Ammonia and dissolved oxygen were within the normal ranges.

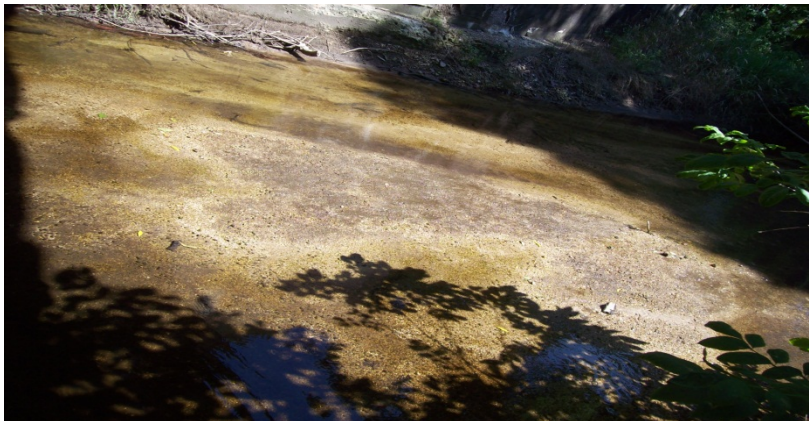
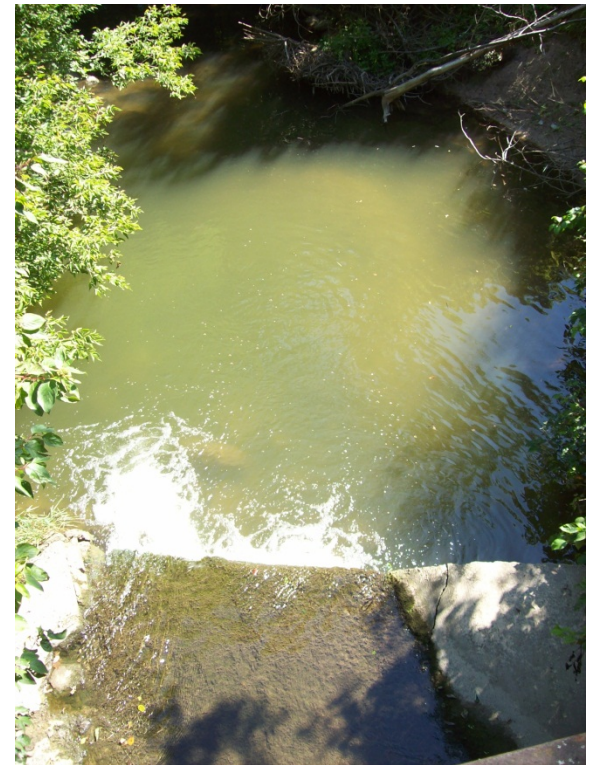
- * Overall nutrients increased downstream
- * Dissolved Oxygen decreased downstream
- * Average Total Dissolved Phosphate was slightly above normal
