Stream Quality Assessment of Southern Manitowoc County -Summer 2017-

Student Interns: Abigail Adams, Paige Arneson, Bethanie Ebben, Matt Reed, Alec Seguin, Nick Wiedemann
Faculty Advisors: Dr. Rebecca Abler and Dr. Richard Hein

Friends of Hika Bay
Calvin, Pine, Point, Fischer, Centerville Creeks

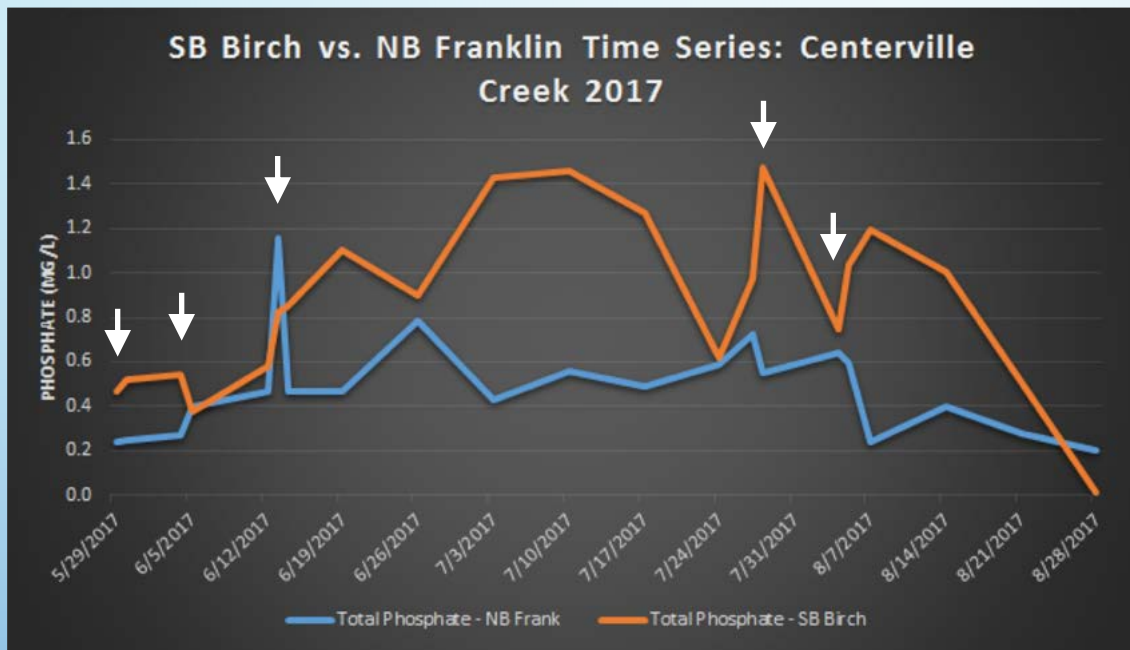
Total Phosphate over time plotting North Branch against South Branch

- Arrows point towards rain events
- 5 documented rain events this summer → however, there are more that we didn't test for

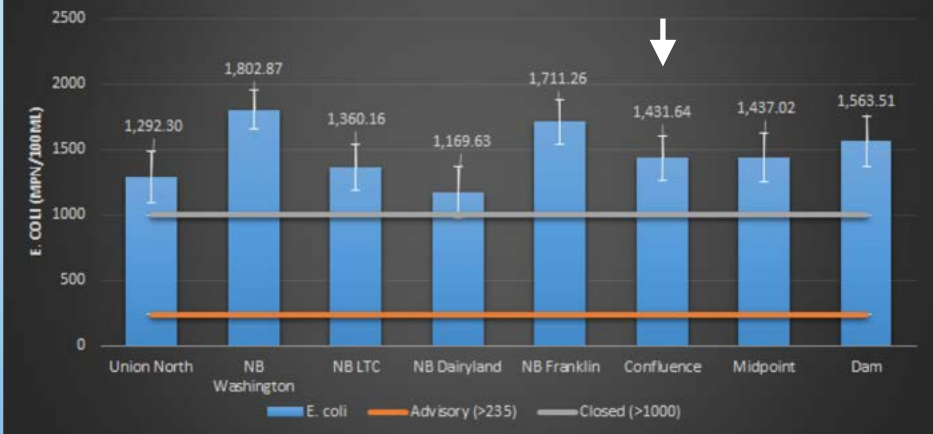
Centerville Creek - North Branch E. coli Averages: 2017

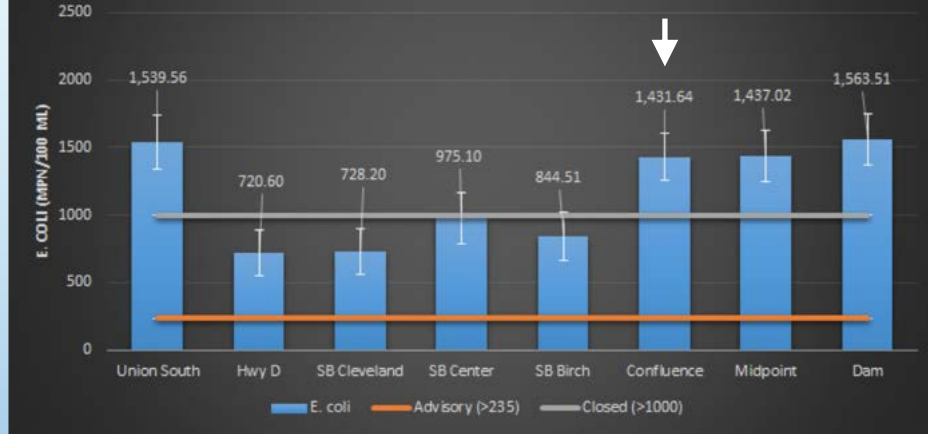
Centerville Creek - South Branch E. coli Averages: 2017

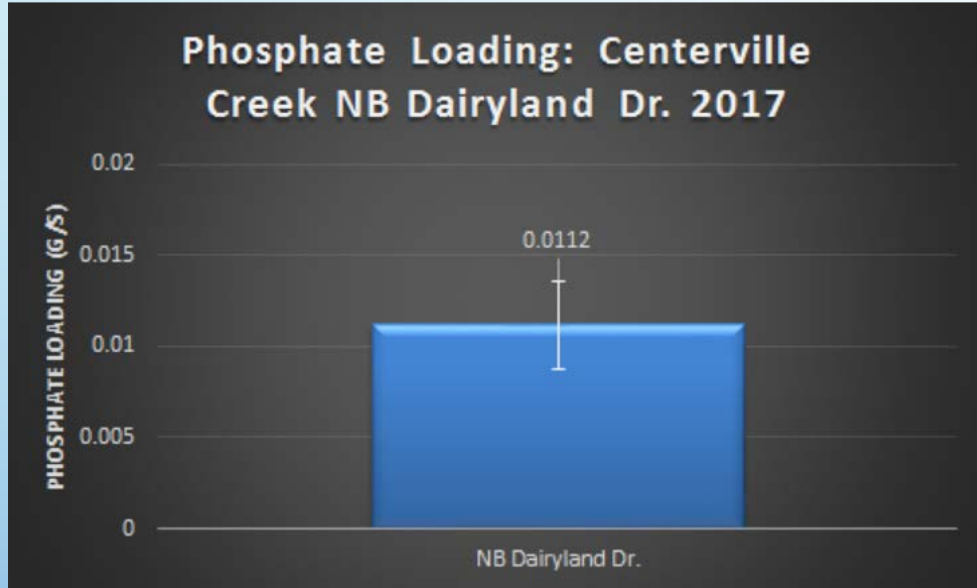
Phosphate Loading Averages

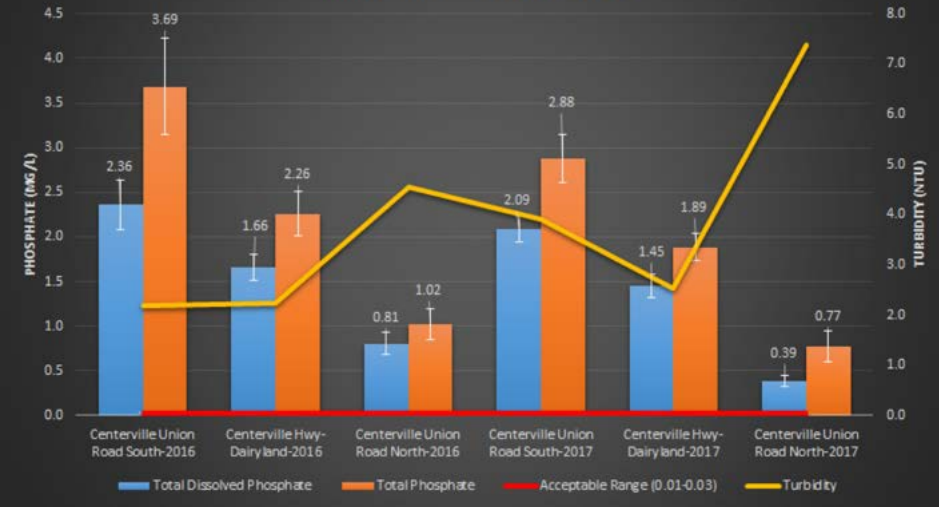
**Total Dissolved and Total Phosphates with Rain Events:
Union Sites 2016 vs 2017**

- Union North does not influence Union South
- Union South is upstream from Hwy D and sediment/contamination is being lost somewhere between the two sites
- Dissolved oxygen levels have improved for Union North and Highway D
 - Union South decomposition
- Turbidity doesn't line up with phosphate values
 - Data without rain events were higher than with rain events
 - Likely that there is another source besides surface runoff
- Phosphate loading:
 - Union South- 0.25 g/s, 333 lbs/week, 4,348 lbs/summer
 - Hwy D- 0.20 g/s, 267 lbs/week, 3,478 lbs/summer
 - Union North- 0.15 g/s, 200 lbs/week, 2,609 lbs/summer

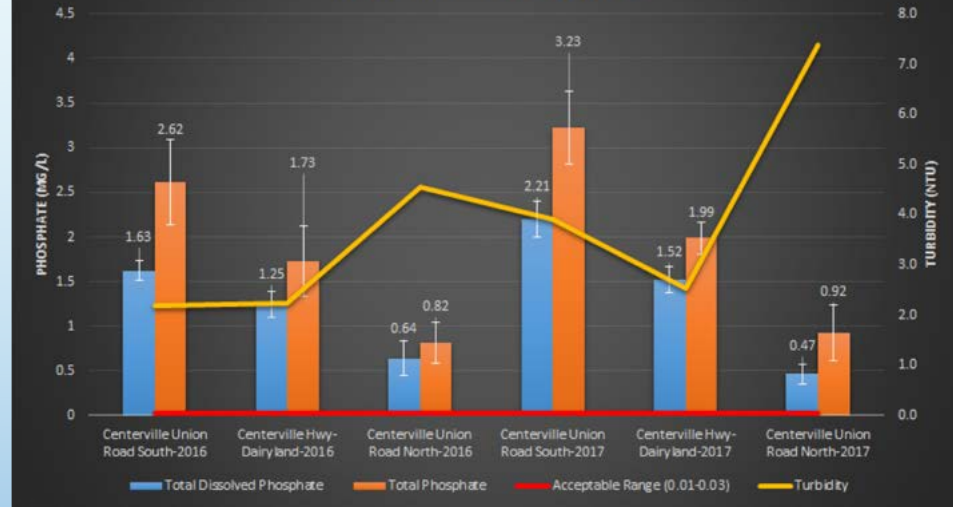
**Total Dissolved and Total Phosphates without Rain Events:
Union Sites 2016 vs 2017**

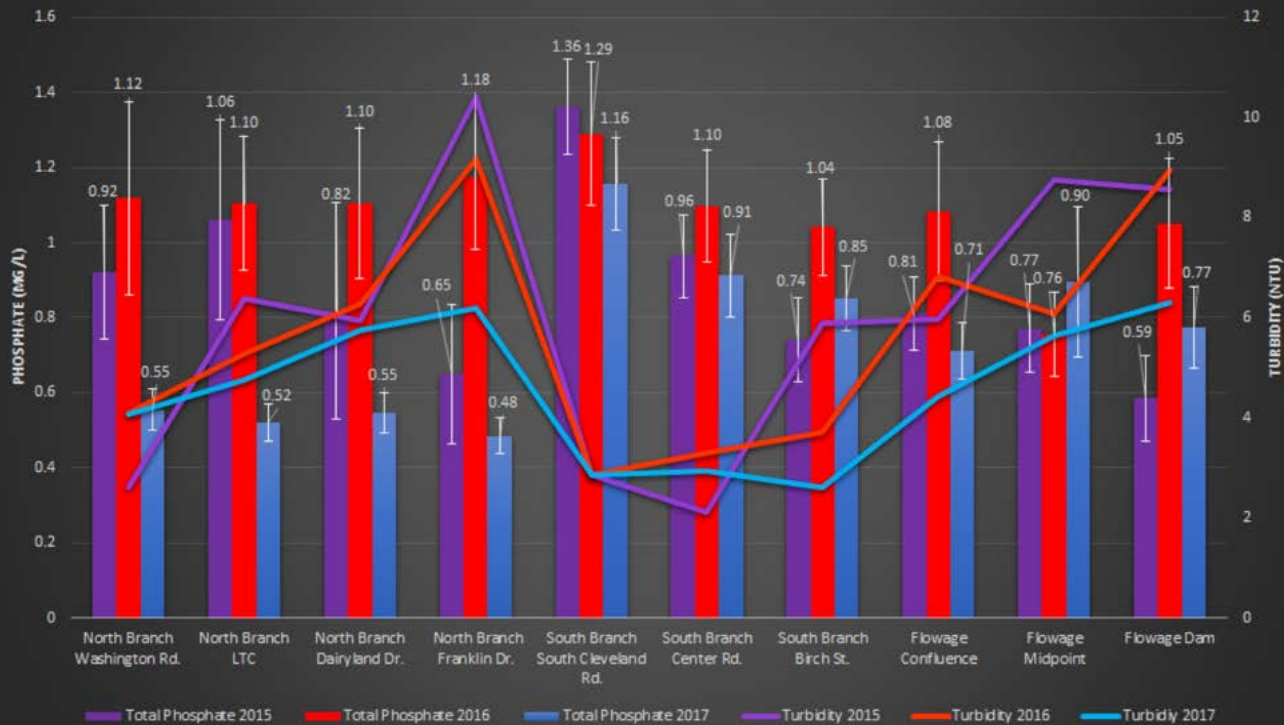
Total Phosphate vs. Turbidity: Yearly Averages

- *Phosphate is marginally trending down overall.
- *All North Branch sites are down significantly.
- *Phosphate levels at all sites are still beyond acceptable range.
- *Turbidity not following phosphate levels.

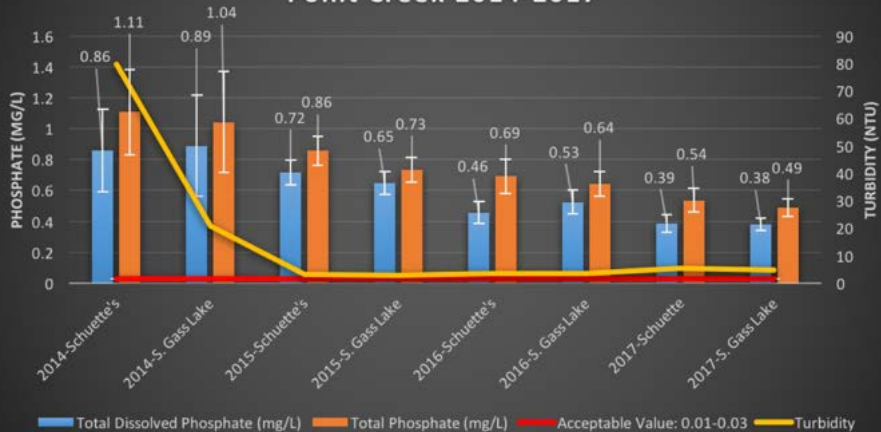
**Total and Dissolved Phosphates with Rain Events:
Point Creek 2014-2017**

- *Phosphate totals decreasing overall, but this trend slowing and still far from optimal range.
- **E. coli* is still well beyond advisory.
- **E. coli* is not decreasing like phosphate.
- *Phosphate levels with and without rain similar..
- *Low turbidity and yet high phosphate levels.
- *Possibly another source of contamination other than surface runoff.
- *No Phosphate loading data.

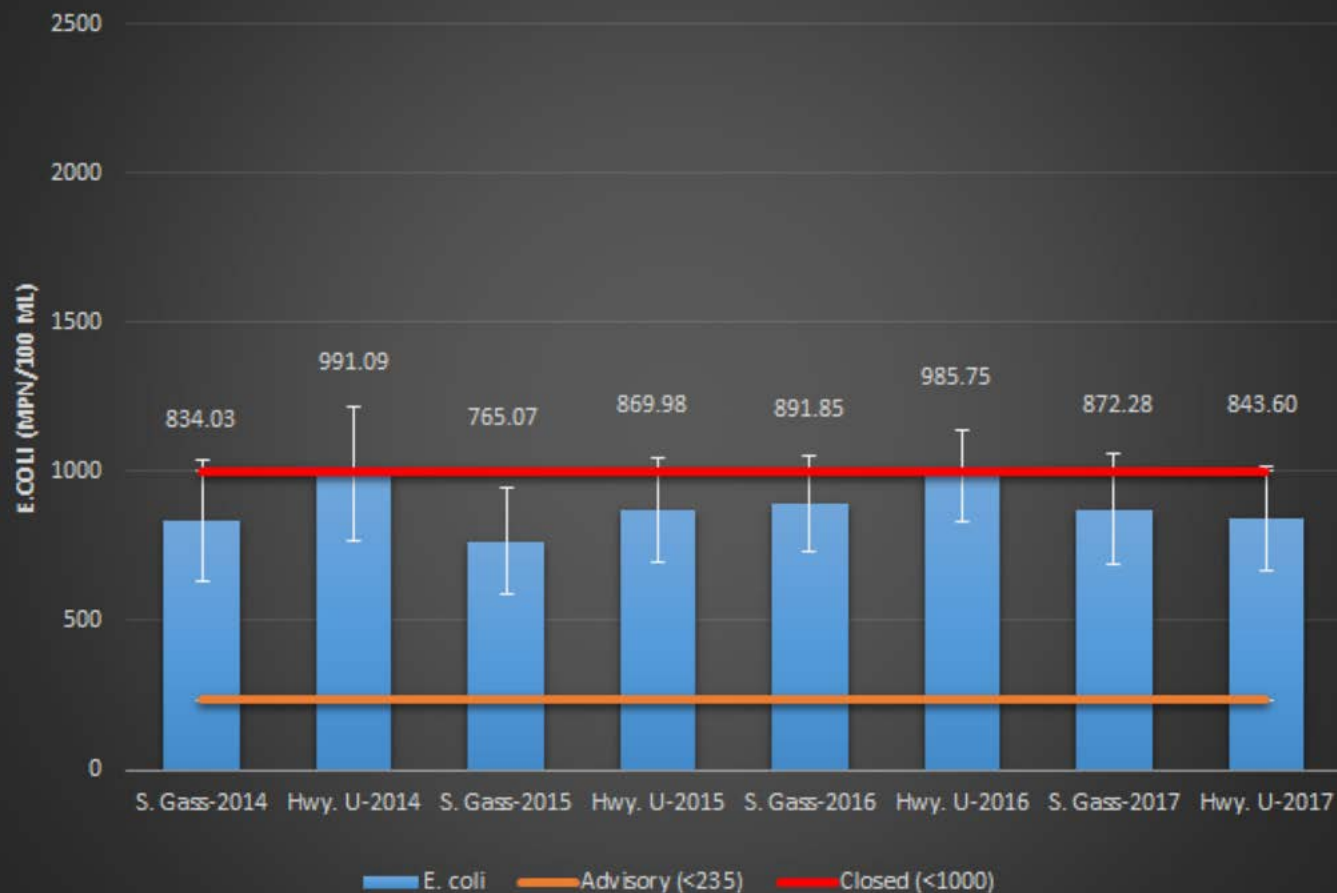
E.Coli Averages: Pine Creek

- Decrease in *E.coli* but still above advisory
- Drastic increase in total and dissolved phosphate, and ammonia nitrogen
- All other parameters similar to past years
- More to come...

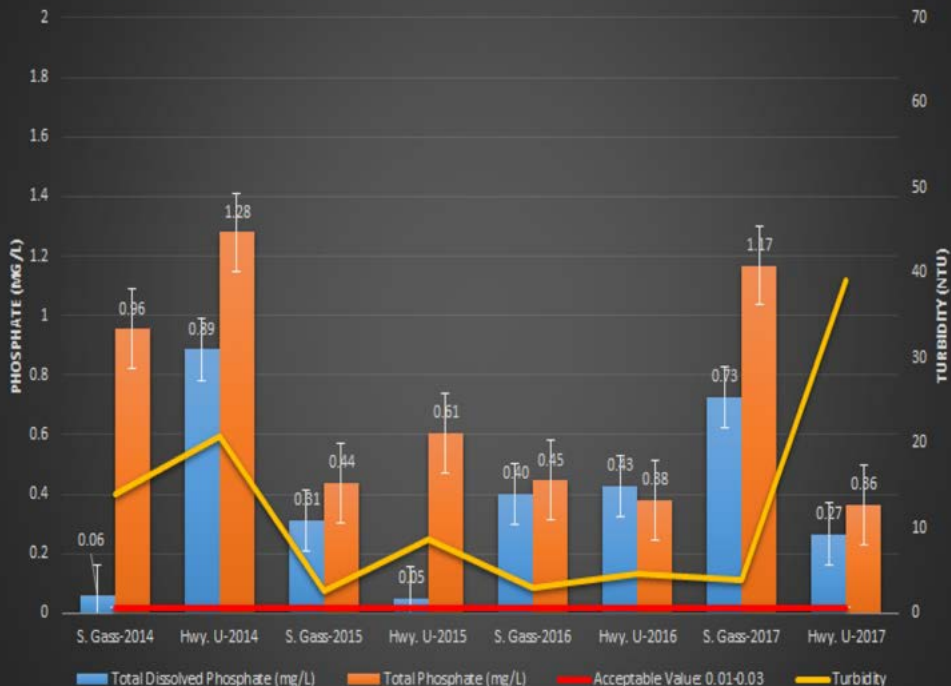
Total and Dissolved Phosphate with Rain Events: Pine Creek

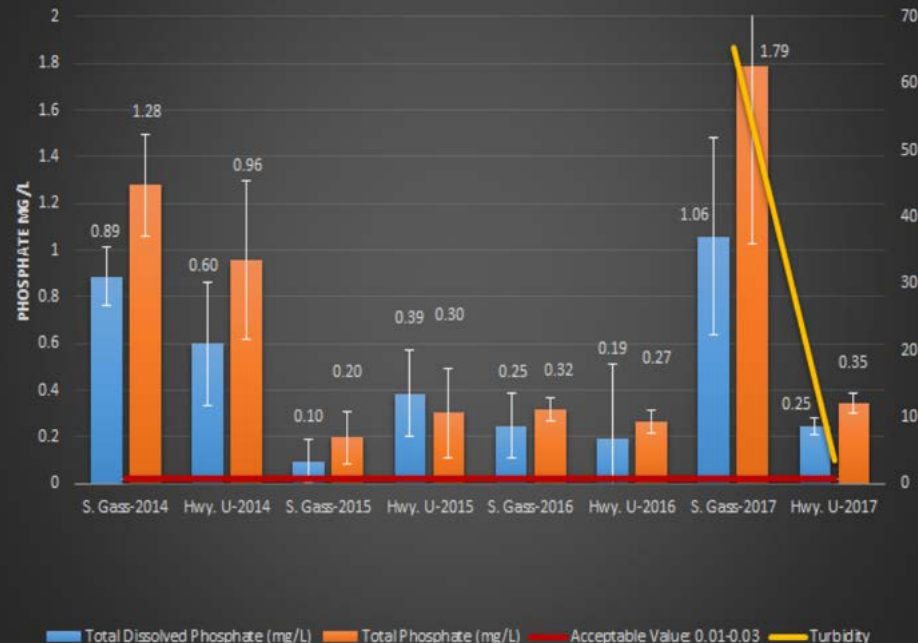
Total and Dissolved Phosphate without Rain Events: Pine Creek

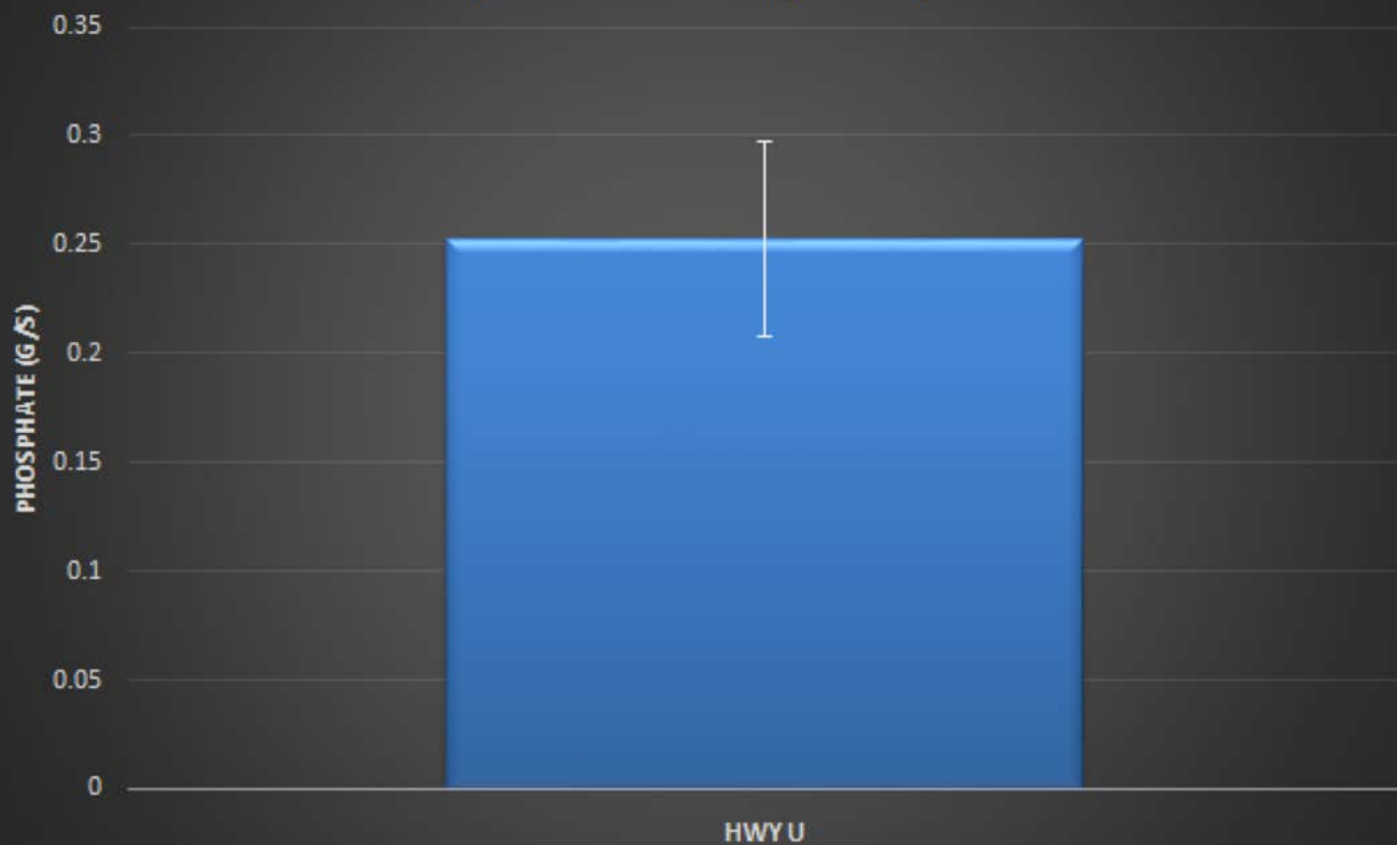
Phosphate Loading: Hwy U 2017

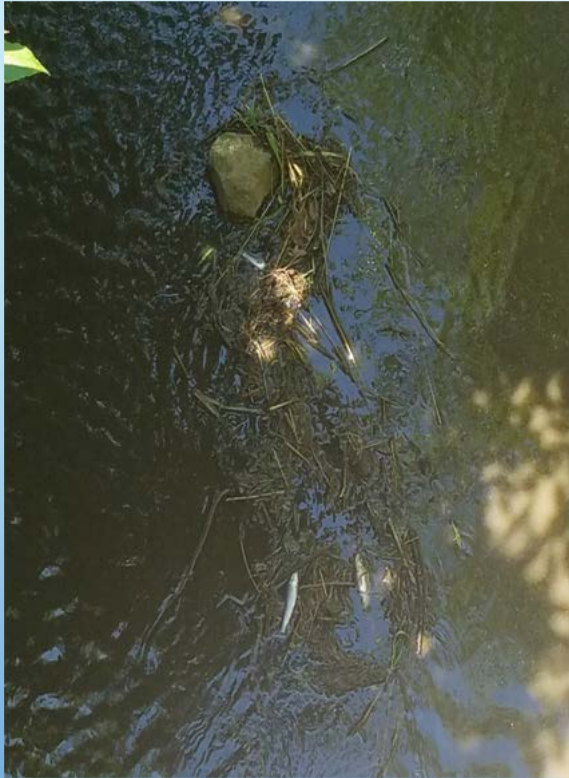
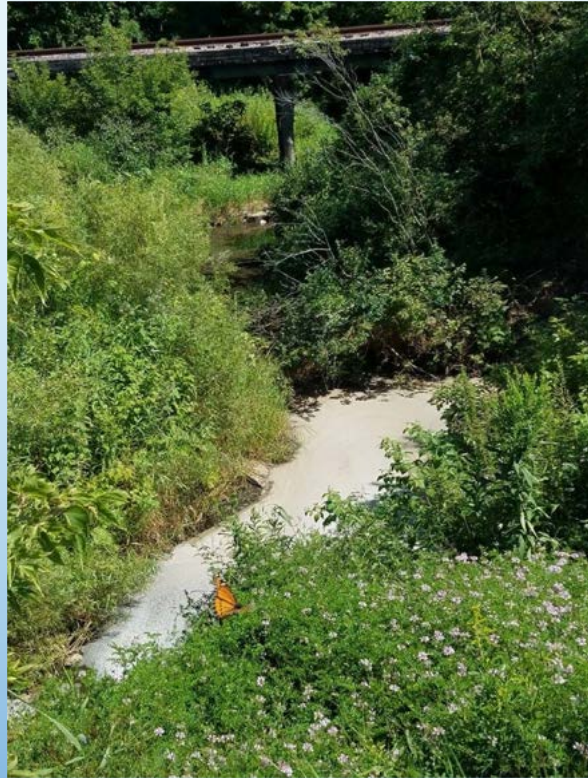
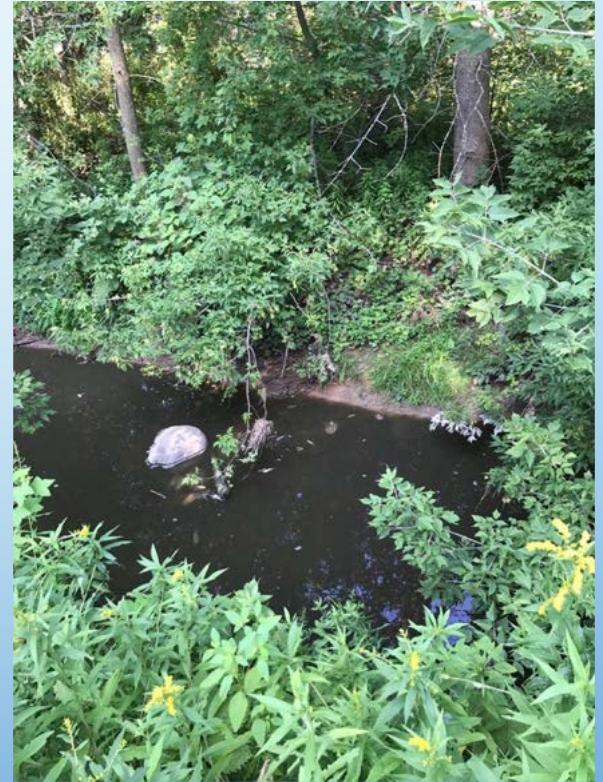
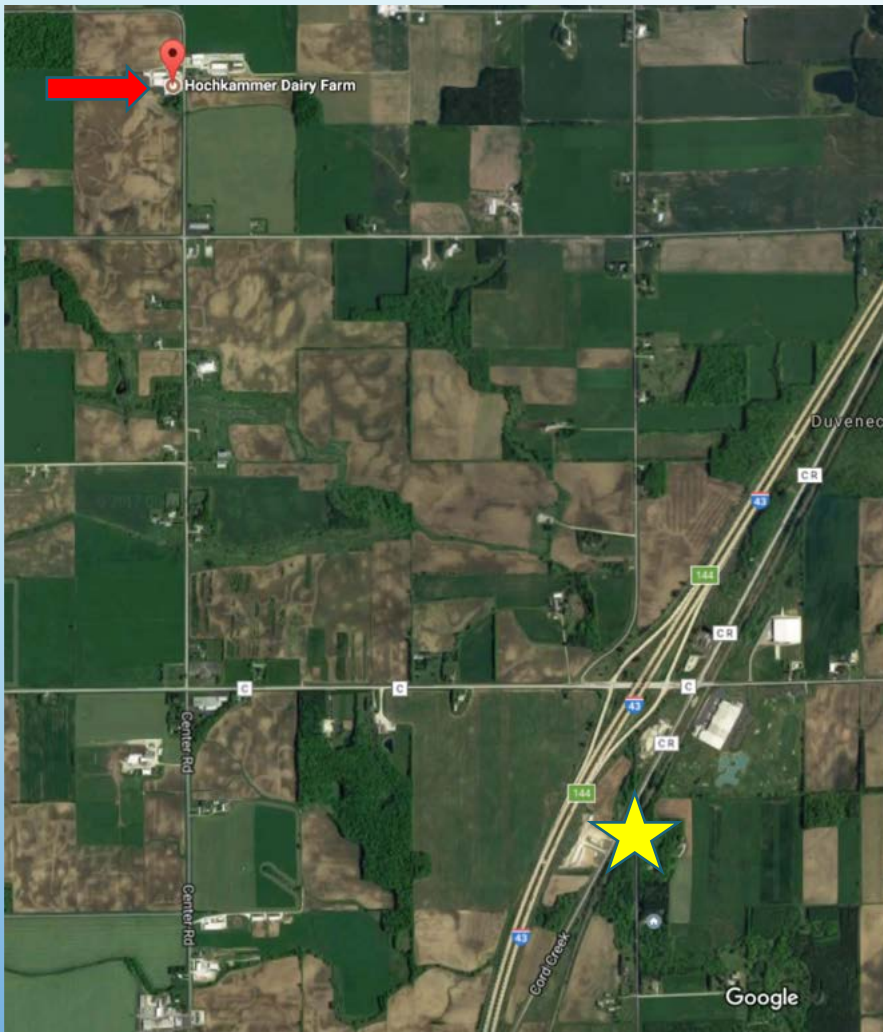
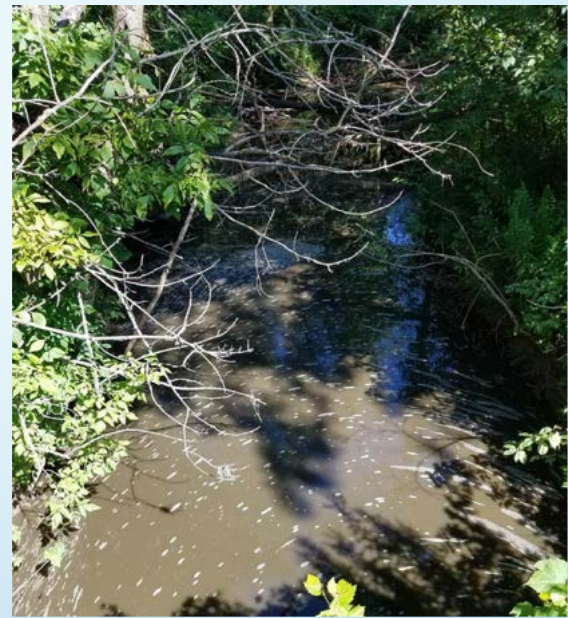
Pine Creek Manure Spill August 7th 2017

- Source: Hochkammer Dairy Farm
- Pine South Gass: 2.8 miles South East
- Concrete plug fail in manure pit
- Discovered early afternoon August 7th
- Manitowoc County lake testing

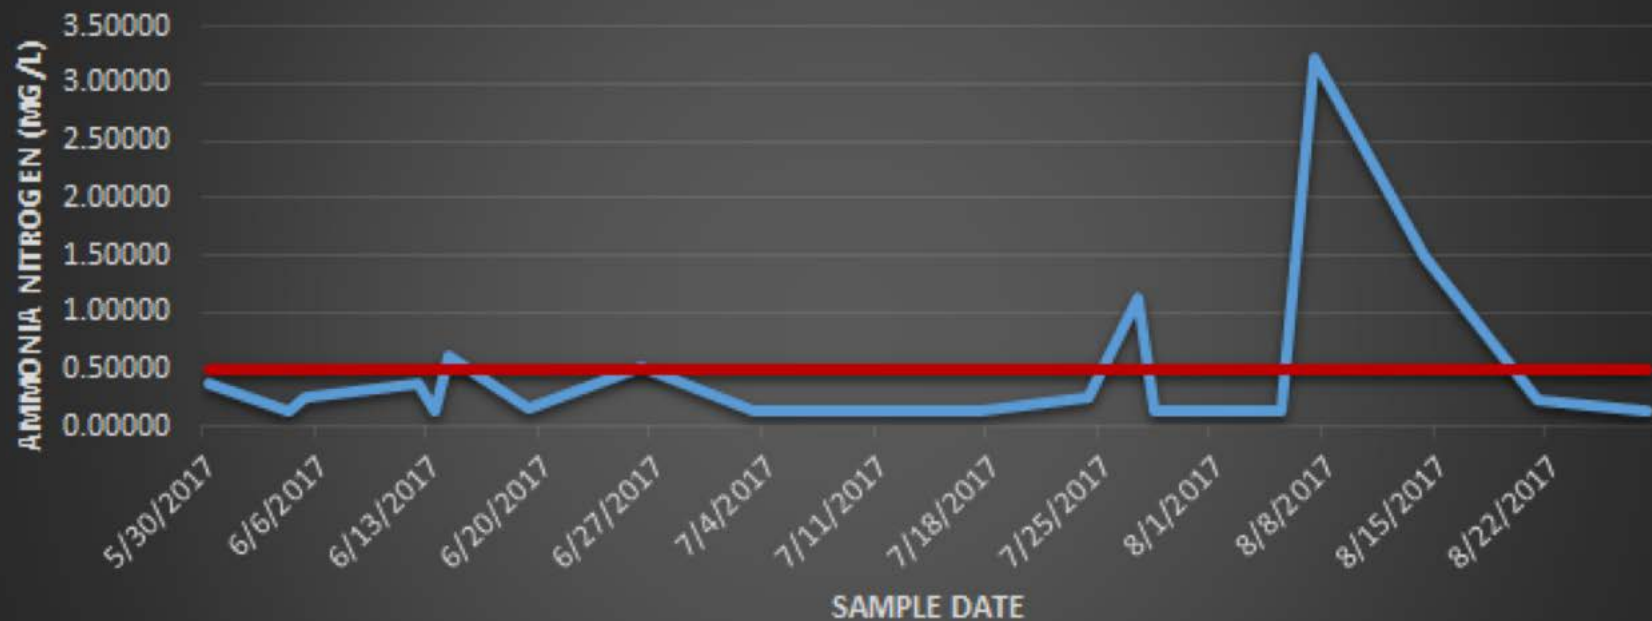
Ammonia Nitrogen (NH₄): Pine S. Gass Lake Rd

Ammonia Nitrogen (NH₄)

Acceptable Range <math>< 0.5</math>

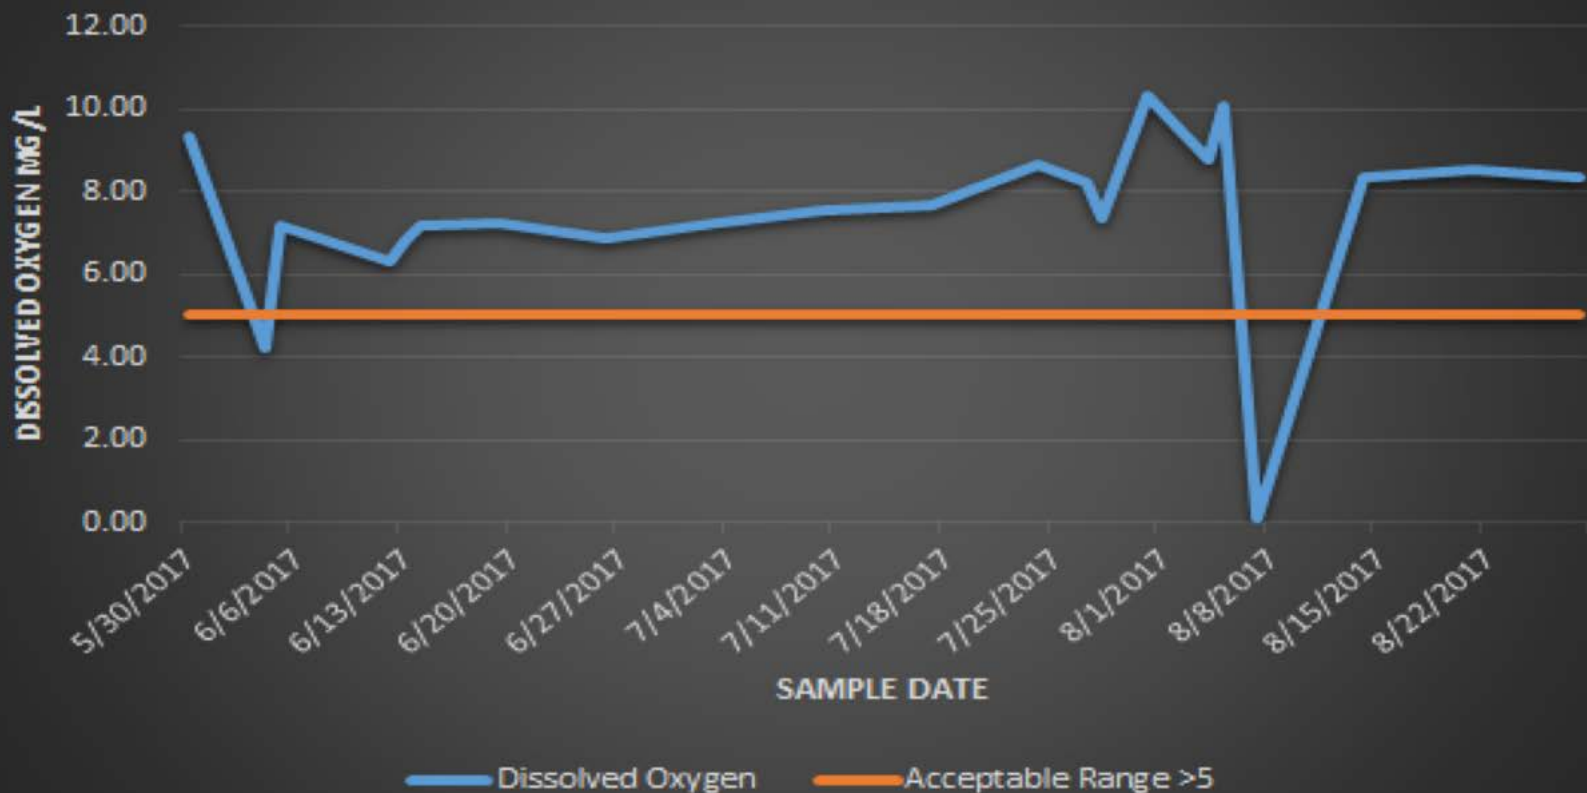
Dissolved Oxygen: Point S. Gass Lake Rd

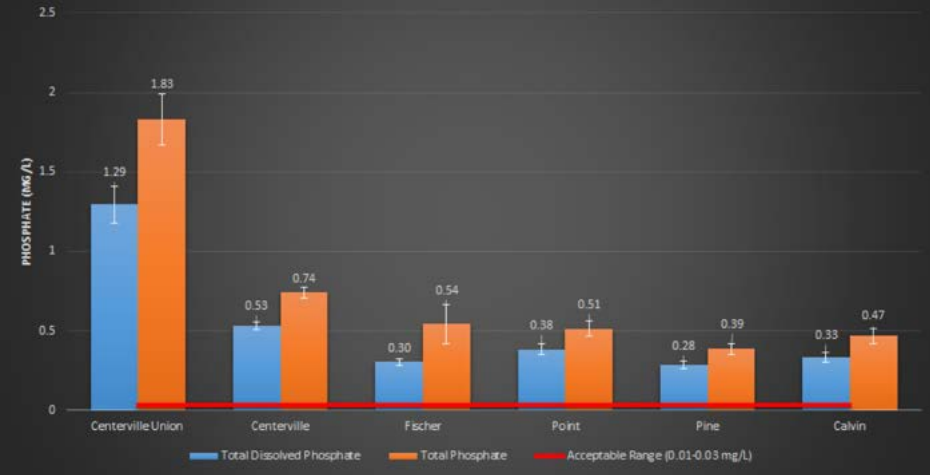
Phosphate Averages with Rain Events: All Creeks 2017

- Pine Creek spill and helping the community
- Union South has some of the highest nutrient input out of all our sites
- E. coli hasn't really changed much over time and remains above safe levels
- No phosphate correlation with rainfall like previous years
 - Phosphates entering stream without rain
 - Turbidity doesn't match up with phosphate levels
 - Not just surface runoff
 - Dissolved and totals are close together
 - Surface runoff would likely increase turbidity
 - Most of the phosphate we found was soluble

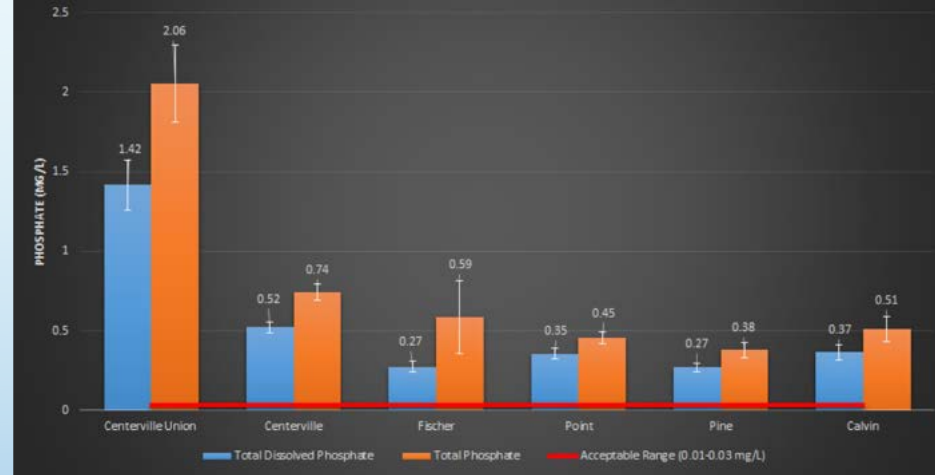
Phosphate Averages without Rain Events: All Creeks 2017
