STREAM QUALITY ASSESSMENT OF SOUTHERN MANITOWOC COUNTY -SUMMER 2018-

STUDENT INTERNS: NICHOLAS GEIGER, MEGHAN JACKSON, ALEC SEGUIN, JOSHUA STECKMESSER, NICK WIEDEMANN

Centerville Creek

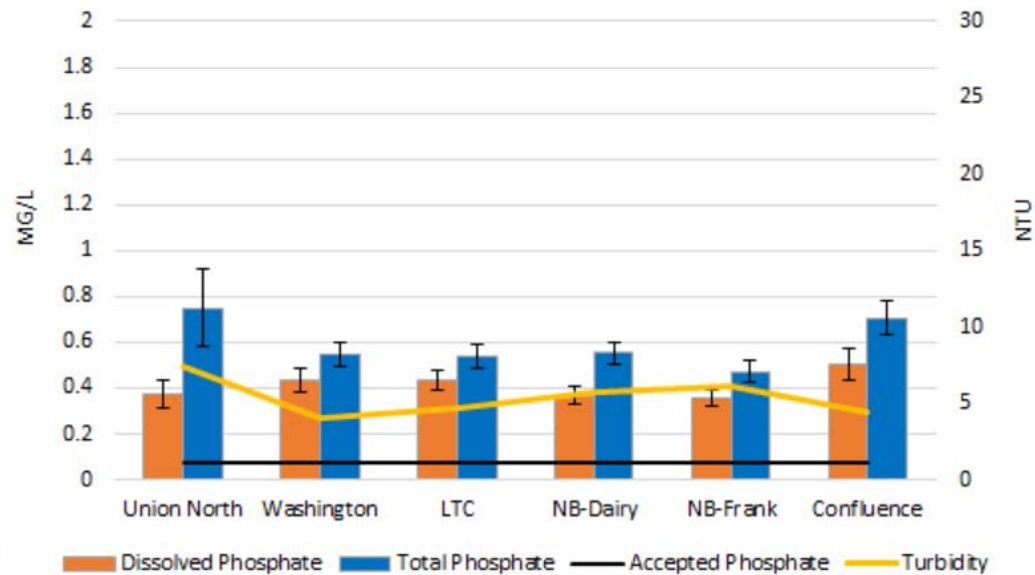
Centerville North Branch Turbidity 2017

- **Phosphate**- Phosphorus is essential for growth and metabolic reaction in plants in animals, though it is detrimental in large amounts. Acceptable Range: 0.075 mg/L (<0.10 mg/L max)
- **Turbidity**- Particles in water (dissolved or suspended) which scatter light causing a cloudy/murky appearance. High turbidity negatively affects aquatic life. Acceptable Range: 1 to 5 NTU

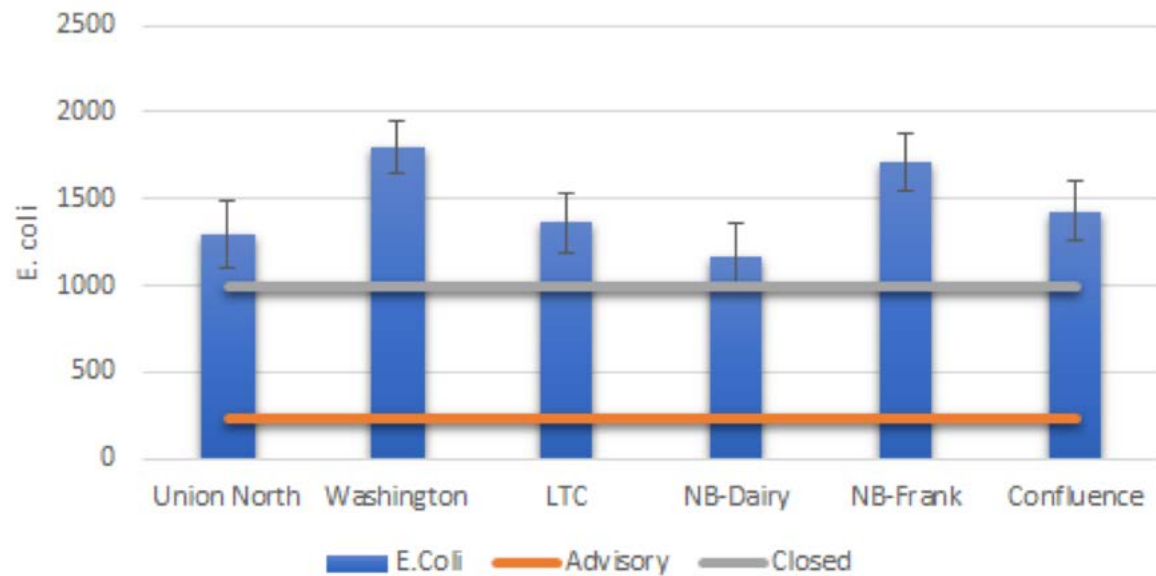
North Branch E. coli Total 2017

- **E. coli**- Bacteria found in the intestines of animals. The presence of E.Coli in water indicates recent fecal contamination. Advisory: >235 Closed: >1000
- **Rain Event**- An accumulation of 0.50 Inches or more within a 24 hour period.
